ON THE LEVEL

MORRIS CANAL
GREENWAY ISSUE

THE CANAL SOCIETY OF NEW JERSEY

THE MORRIS CANAL GREENWAY

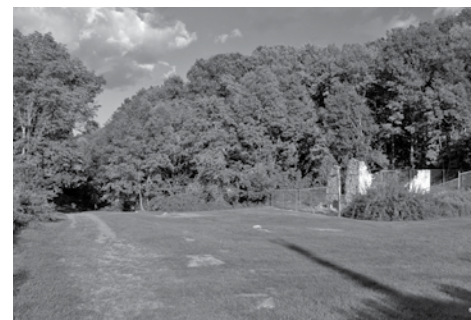
In this 2007 photo, Lock 2 East lies buried just below the surface of a grassy field. The ruins of the lock tender's house are seen in the distance on the right

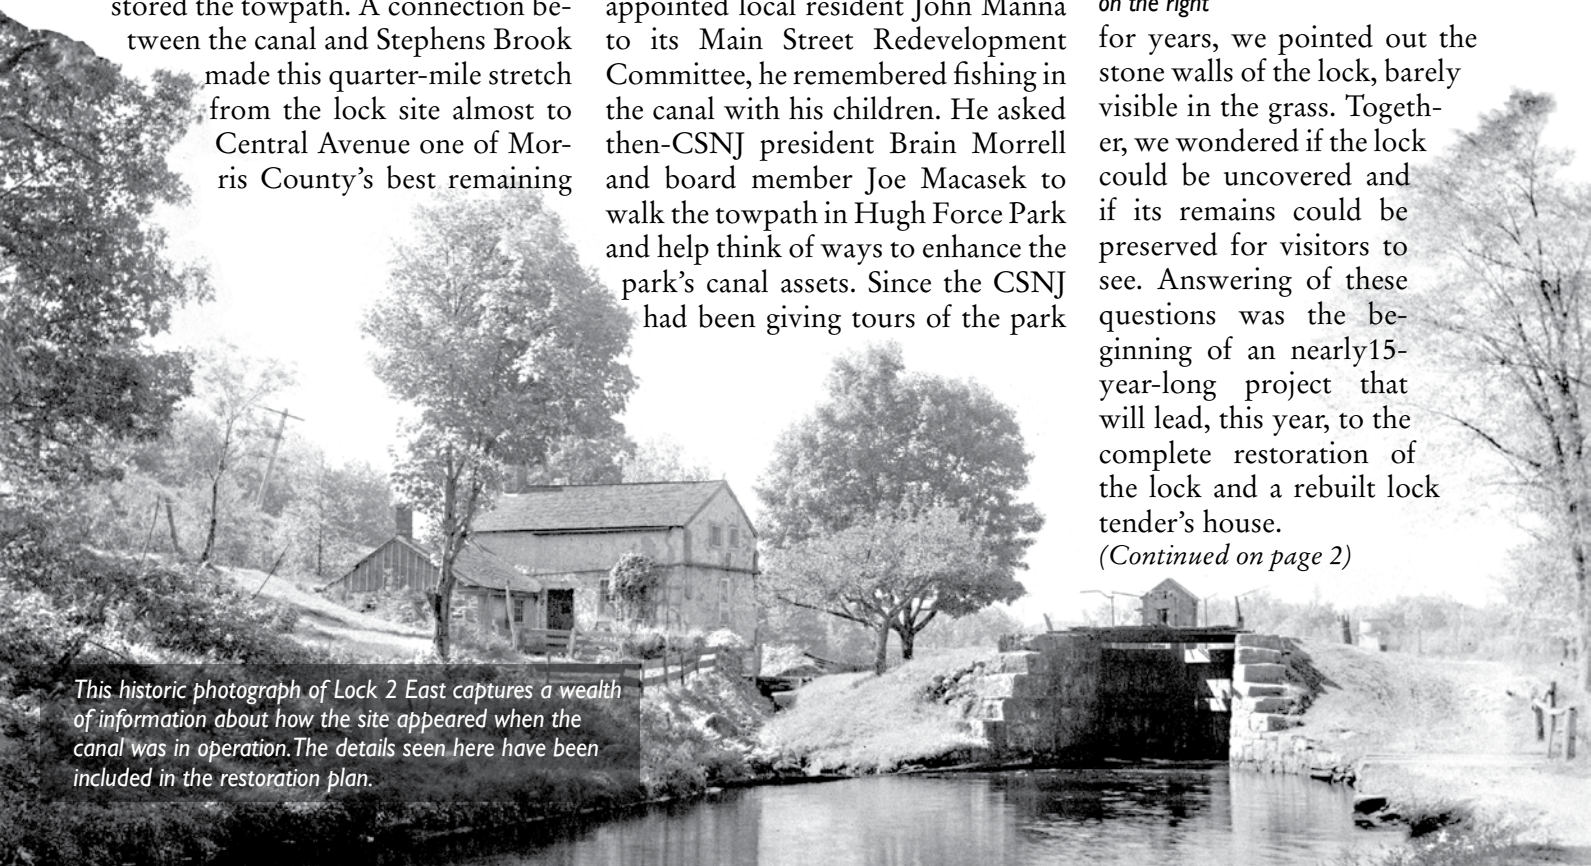
This historic photograph of Lock 2 East captures a wealth of information about how the site appeared when the canal was in operation. The details seen here have been included in the restoration plan.

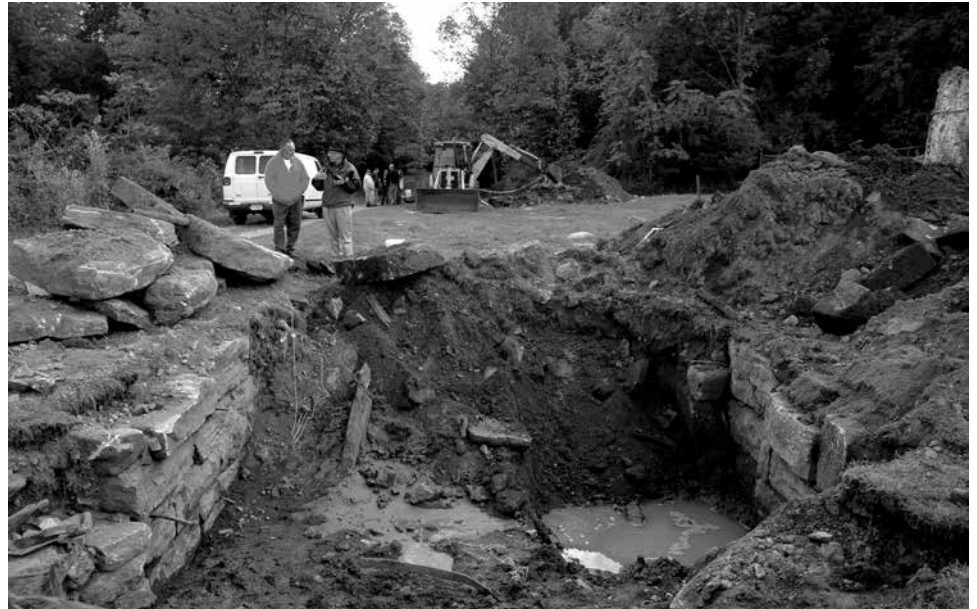
In 2006 project manager John Manna and local historian Richard Cramond visit the lock site to inspect the work as a team of archeologists use a backhoe to partially clean soil from the upper and lower ends of the lock chamber. To everyone's surprise, they discovered that the lock had been only partially dismantled and that the lower walls and substructure were in good condition.

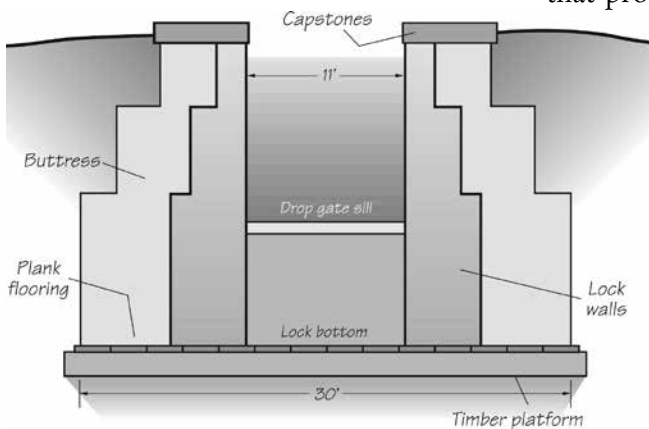
ABOVE: This typical cross section shows lock walls topped with large capstones and supported by heavy outer buttresses, forming an eleven-foot-wide lock chamber between them. The walls rest on a thirty-foot-wide timber platform that makes the lock a single stable unit.

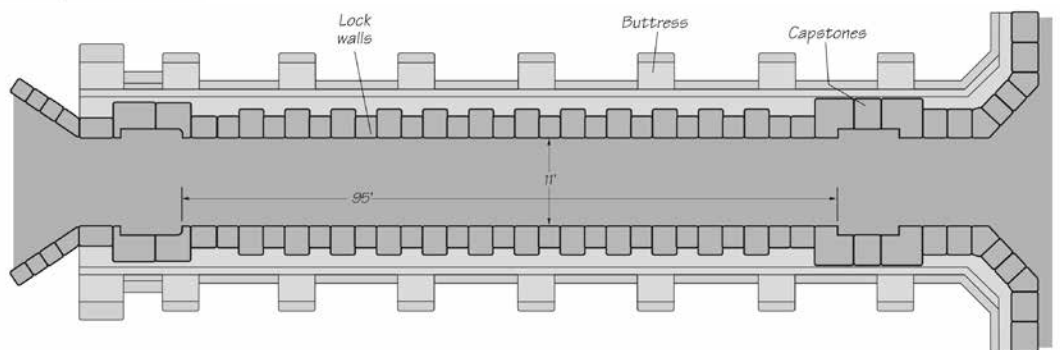
RIGHT: This plan view shows how much stonework it took to create the ninety-five-foot-long chamber in which boats were raised and lowered.

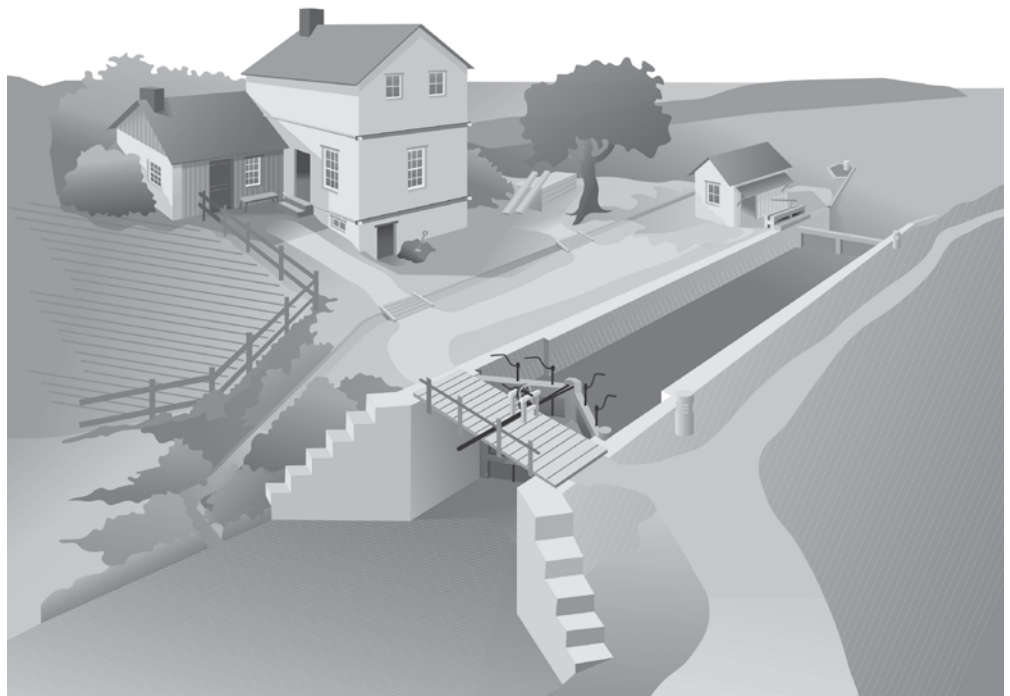
This illustration, based on historic photos, shows Lock 2 East as it was when the canal was in operation. To date, the lock was been carefully rebuilt and new lower lock gates installed. In the current construction phase, the lock tender's house and shanty will be rebuilt. In addition, remaining lock gates and hardware will be installed to make the lock operational.

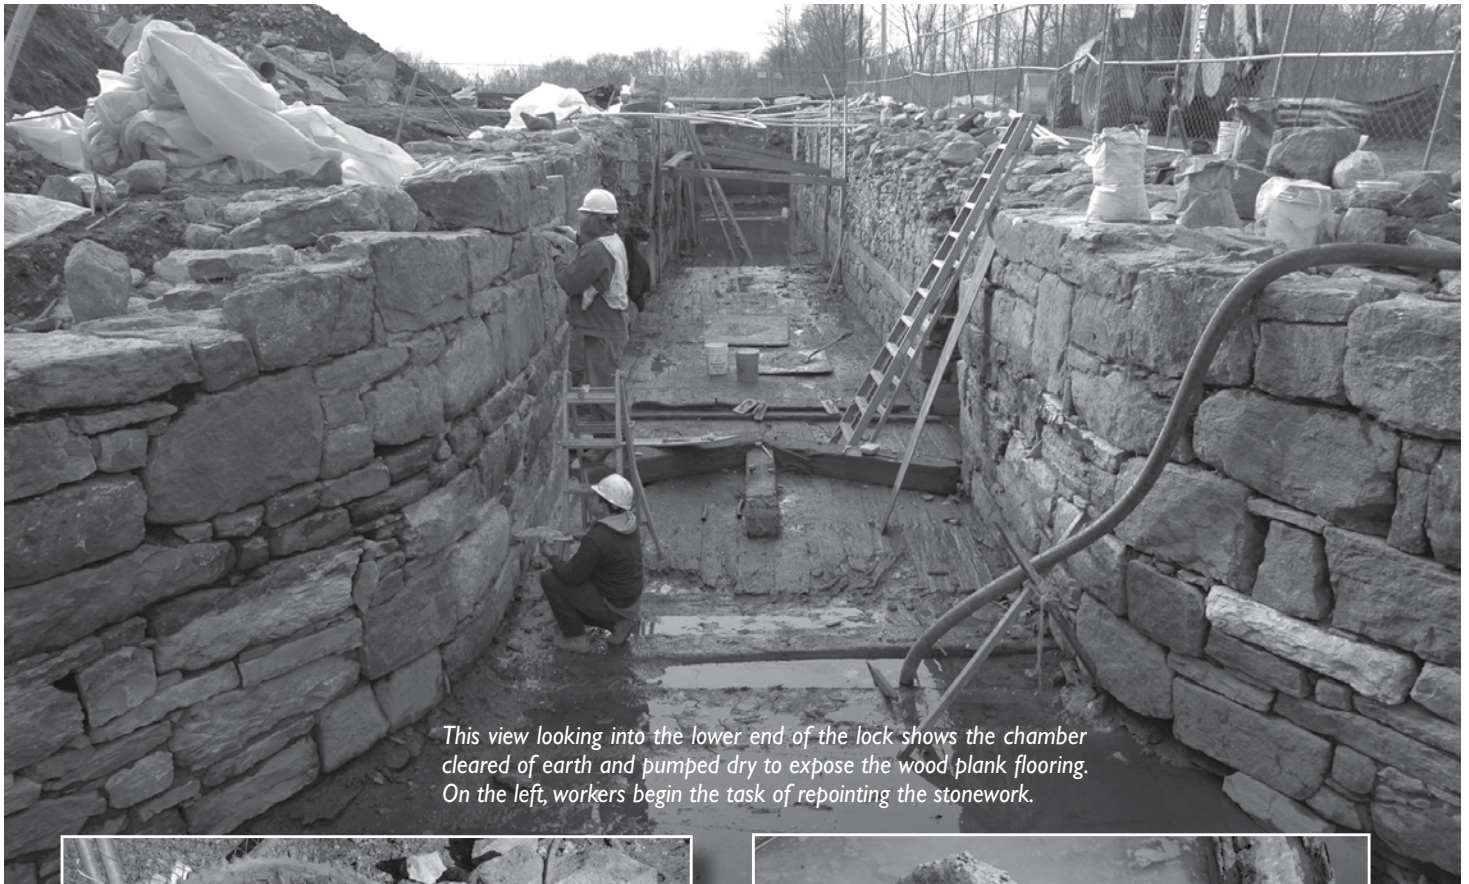
This view looking into the lower end of the lock shows the chamber cleared of earth and pumped dry to expose the wood plank flooring. On the left, workers begin the task of repointing the stonework.

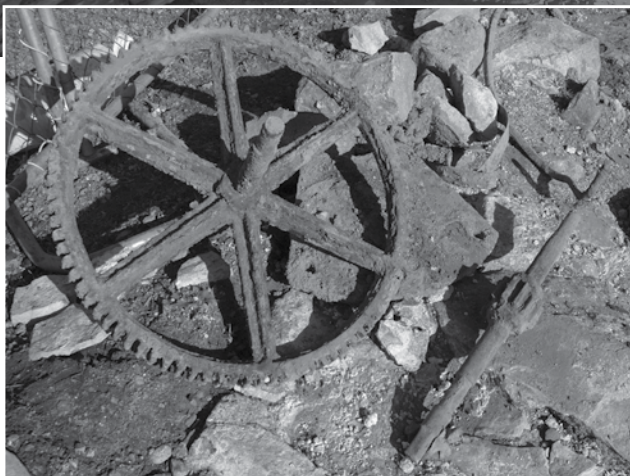
These gears are part of the rack and pinion that enabled the lock tender to crank both lower lock gates open or closed.

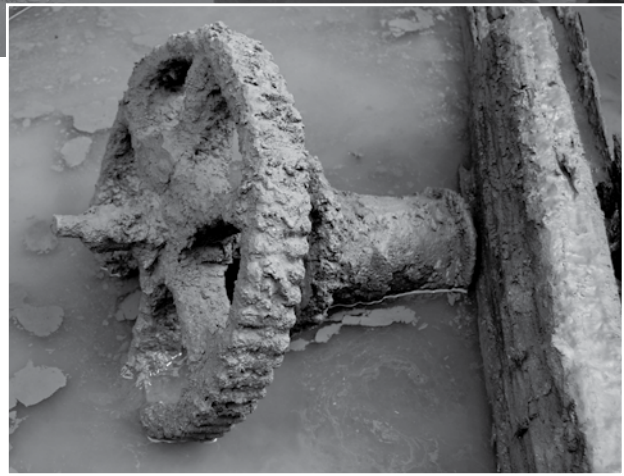
Still covered in mud, this gear and drum wound the chain that pulled the upper drop gate into its upright position.

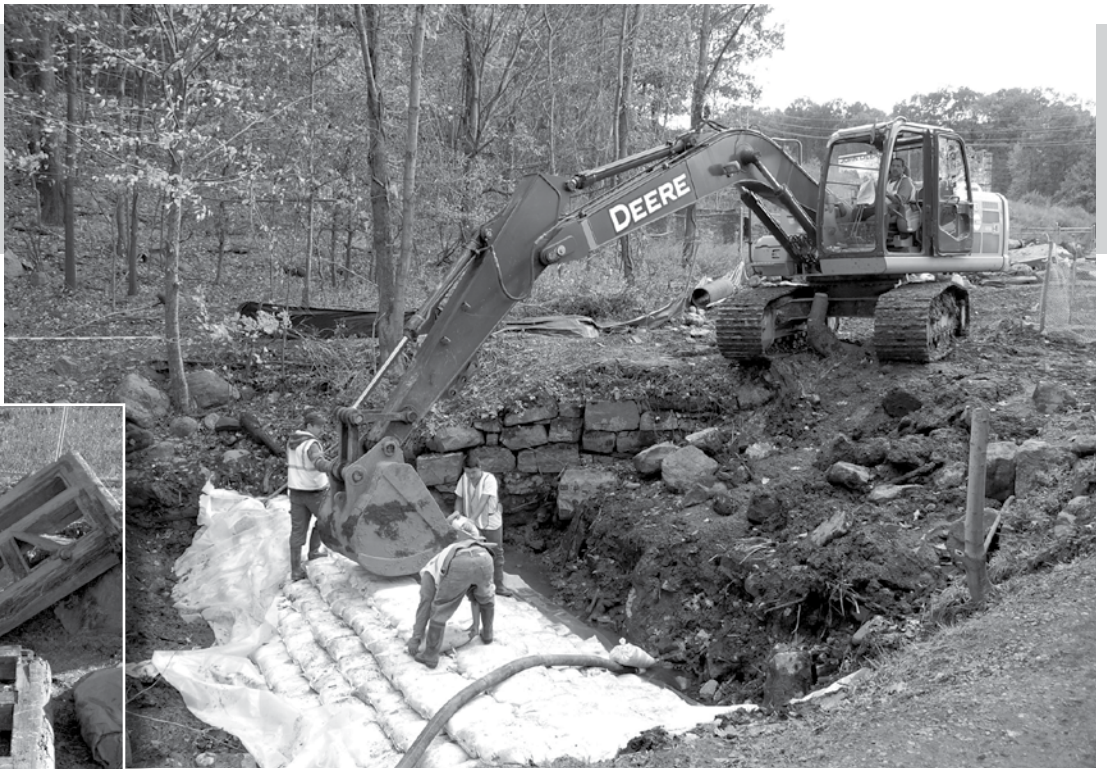
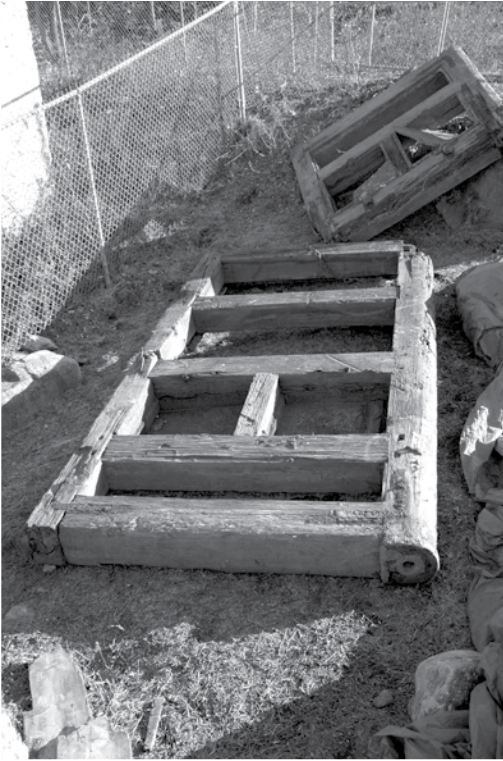
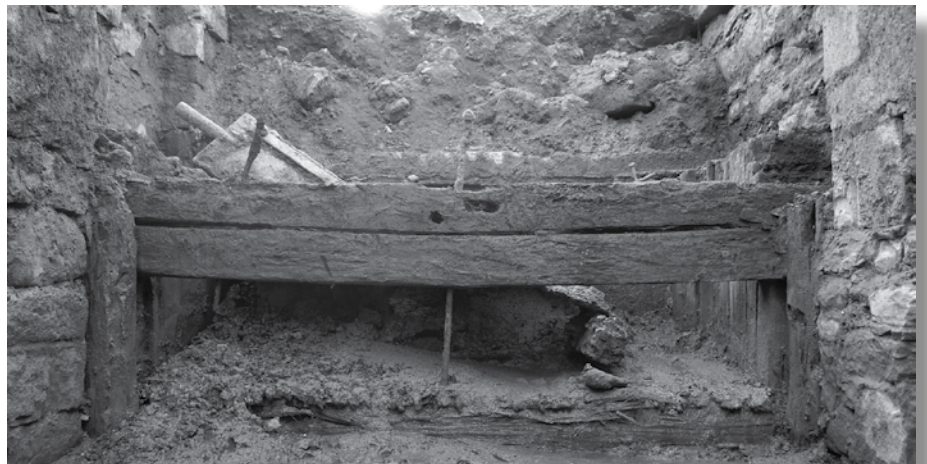
A backhoe perched on the end of the earth-filled lock delivers sand bags to workmen building a cofferdam to prevent water from the canal from filling the lock excavation.

Both massive miter gates were found during the excavating work and are seen here after being removed from the lock chamber.

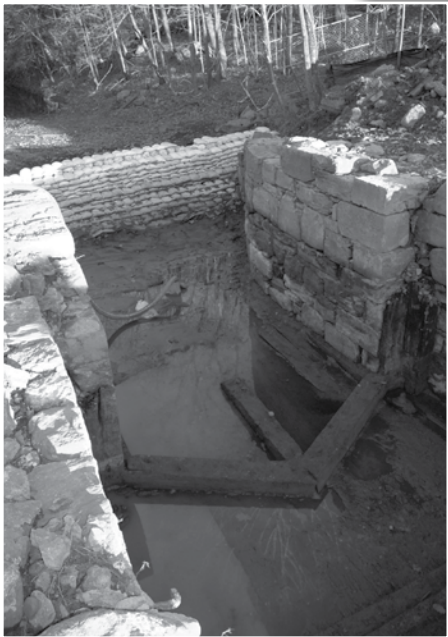
The heavy timbers fastened to the floor of the lock are the sills against which the lock gates rested when in the closed position.

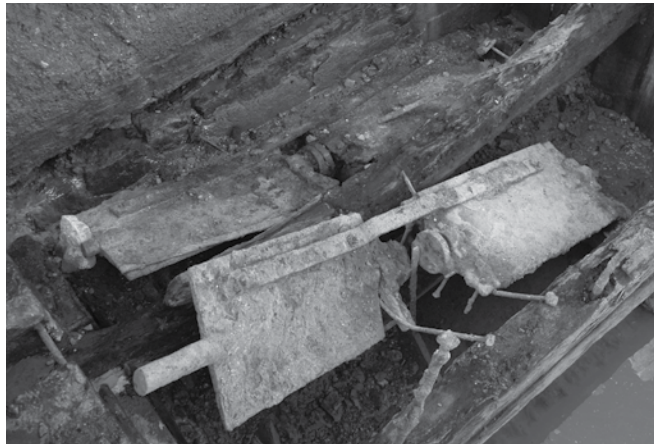
The wicket valve assembly, consisting of four iron shutter gates, had been knocked askew by falling stones when the lock was being filled in during the abandonment. Each shutter weighs several hundred pounds.

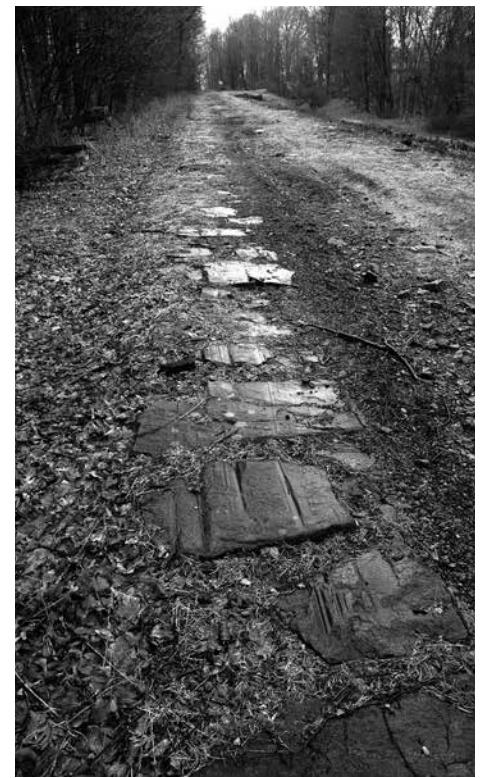
This line of sleeper stones, scarred from years of use, stretch the full length of the slope of Plane 2 East.

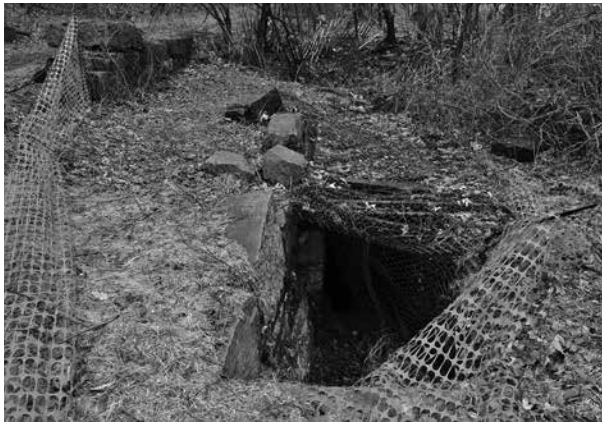
The top of the turbine chamber shaft before restoration.

ect proceeded in phases starting with archeology and an engineering study that showed that there was another problem. When the chamber had been cleared, the top of the turbine chamber shaft was left flush with the ground and covered with wire fencing to keep visitors from falling in. This, however, had allowed rain water to seep into the upper stonework, and with freeze-thaw conditions over the years, had caused damage there as well.

At ground level, the walls of the turbine chamber shaft were extended above grade using stones that had been pushed into the pit years before. The new walls were topped with blue-stone slabs and an iron grating that allows visitors to see into the chamber below without the danger of falling in. To solve the drainage problem, a pavilion was erected over the new construction with a drainage system that carries water away from the site rather than into the stonework below.

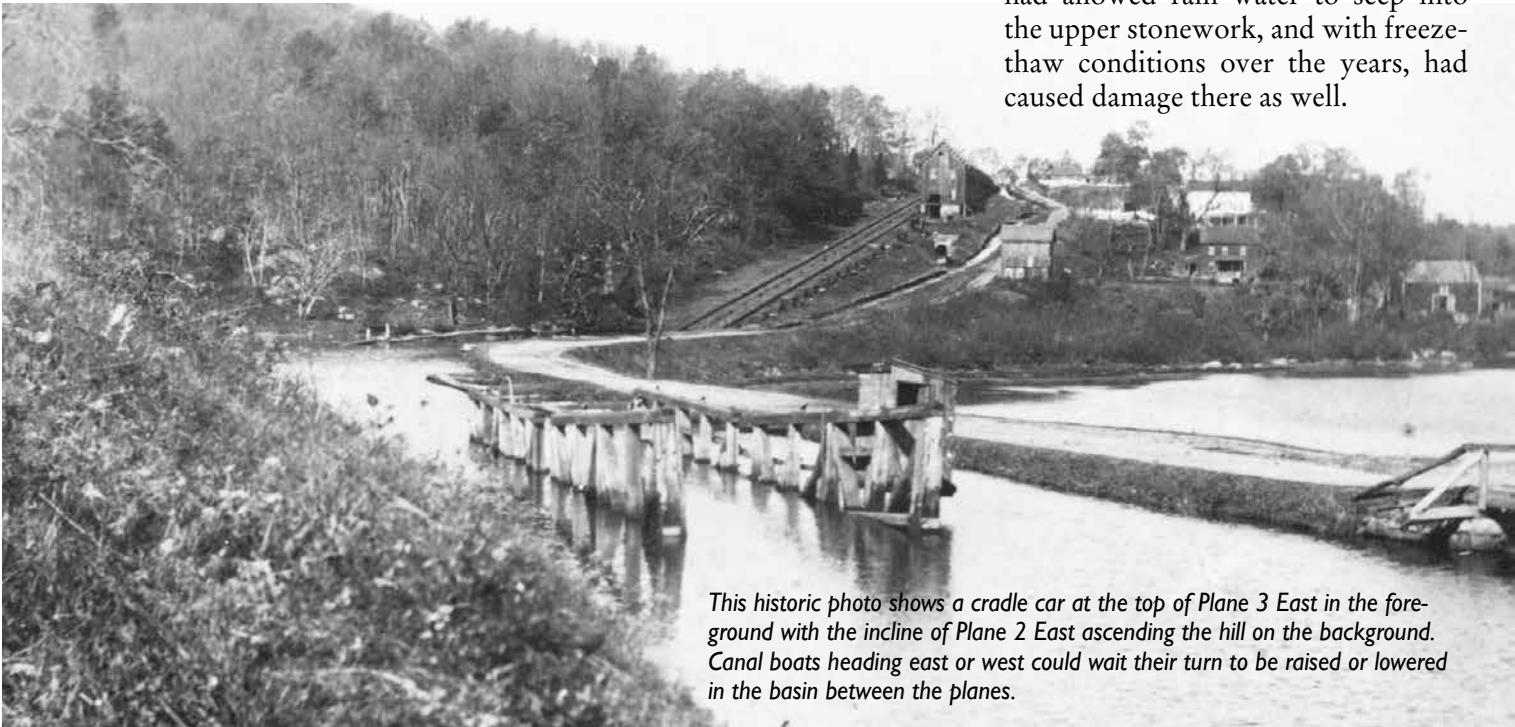
This historic photo shows a cradle car at the top of Plane 3 East in the foreground with the incline of Plane 2 East ascending the hill on the background. Canal boats heading east or west could wait their turn to be raised or lowered in the basin between the planes.

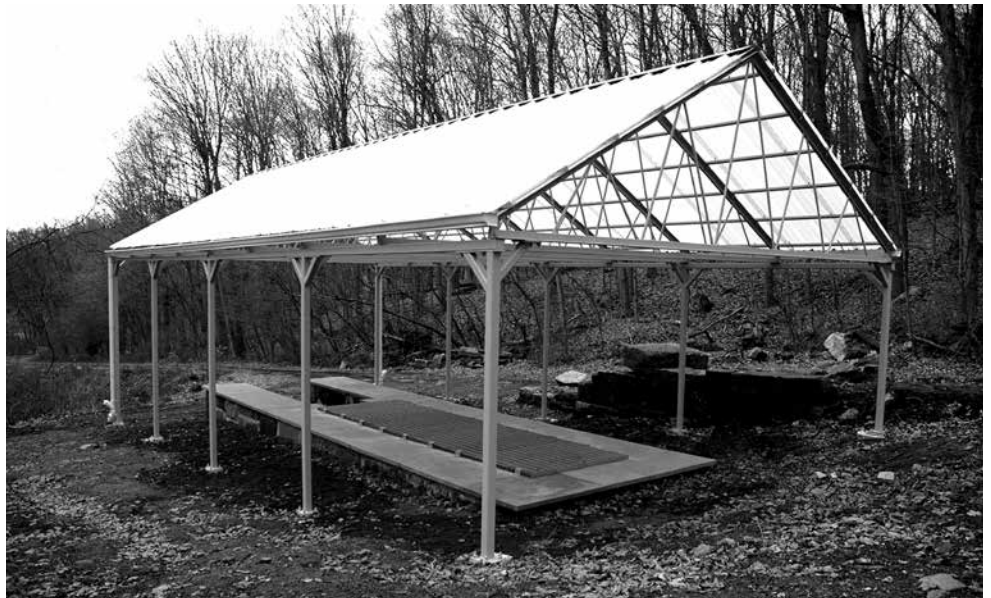
To complete the project, this pavilion was erected over the top of the turbine shaft to prevent ground water from once again working its way into the stonework below.

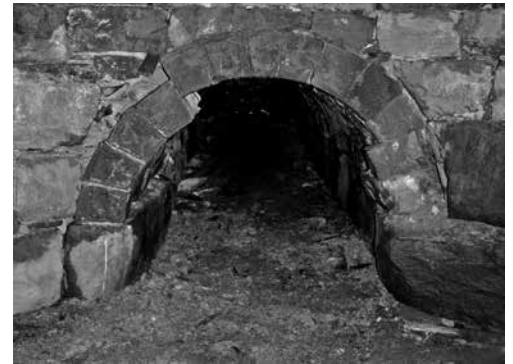
However, in 2007 historians discovered that the massive stonework of the turbine chamber was in danger. The timber flooring upon which the stonework rested had been exposed when the chamber was cleared and, over time, had rotted away. Without a footing, the tailrace tunnel arch had settled on the north end; it had moved out of alignment and was threatening to fail. A collapse might threaten the integrity of the entire structure.

In the photo above, the stones in the tailrace arch without a proper footing have slipped out of alignment and the arch was about to fail.

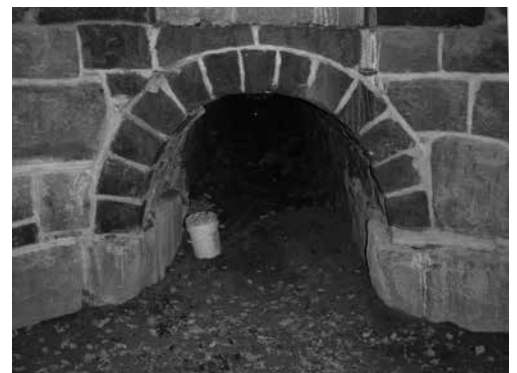
To solve the problem, masons added new concrete footings, realigned the arch and repointed all the stonework.

The stabilization and restoration work began by adding a new concrete footing to support the sides of the tailrace arch. With the new footings as a base, the stones of the arch were carefully jacked back into alignment. To complete the work, masons then repointed the rest of the stonework to maintain its good condition.

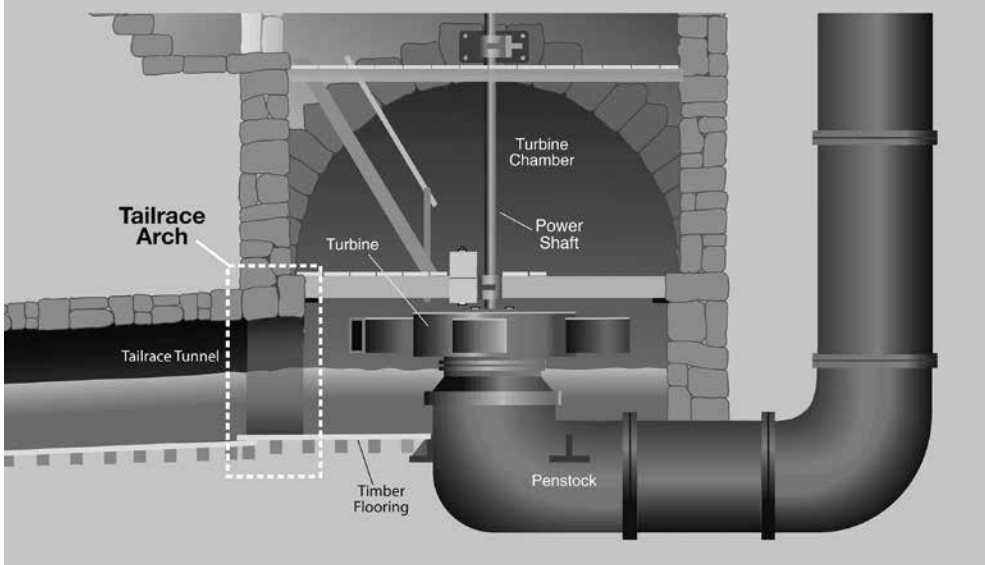
The turbine chamber was a massive stone structure built to hold a huge cast iron machine meant to take in and then eject thousands of tons of water. The wooden platform on which it was built kept the walls from being undermined by

the rushing water. When the chamber was cleared its wooden underpinning deteriorated, in most cases, settled evenly into disuse. However, the tailrace arch, highlighted in the drawing below, settled unevenly and was about to collapse.

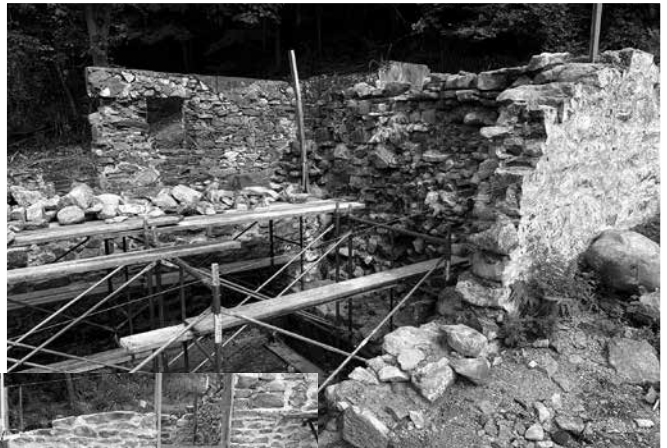
In this photo taken in mid-July, the contractor has removed the existing walls of the lock tender's house down to usable stonework and re-excavated the rubble-filled basement. Scaffolding has been placed inside the building as a platform from which masons can start rebuilding the exterior walls.

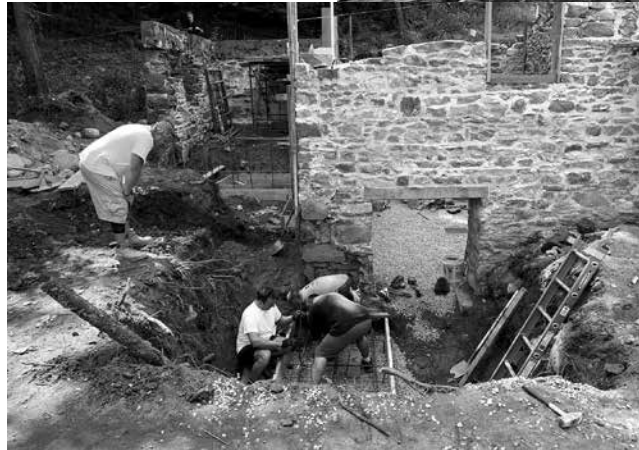
By August, the height of the walls was beginning to rise with the masons framing out the door and window openings as they go. To adhere to modern building codes, proper footings are required for any wall that is being completely rebuilt. In this photo, workers are building a form for the footing of the retaining wall that will allow access to the entrance to the basement level.

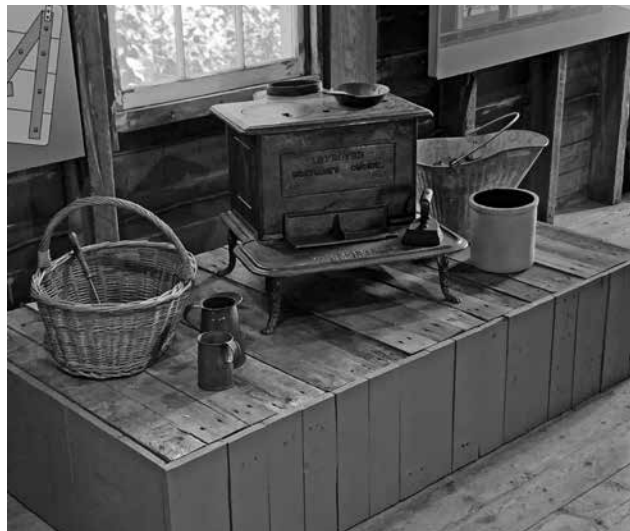
The new canal boat stove, now on display in the Canal Boat Exhibit at Waterloo, surrounded by the items needed to start dinner for the crew.
